Belzona SF6-FIX

The online solution for SF₆ leaks

Power Distribution Substation, UK, 2023

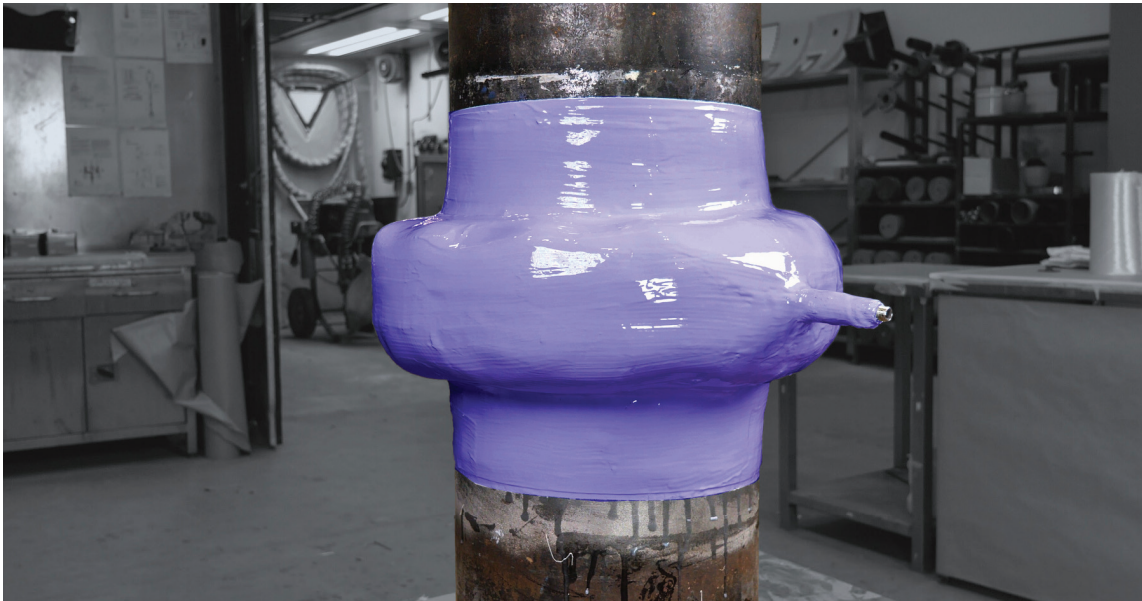
Belzona SF6-FIX is a sulphur hexafluoride (SF₆) leak sealing solution that can be applied online and without specialist tools. With Belzona SF6-FIX, leaks can be quickly and effectively reduced to undetectable levels, resulting in huge environmental and financial savings.

By using solvent free and cold applied products, Belzona can safely seal SF₆ leaks, repairing the asset and protecting the environment. Plus, this durable system of expertly applied specialist materials can be applied in just one day.

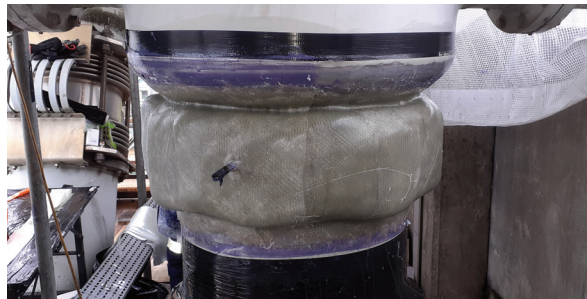
Belzona 7311 applied to breather membrane with Belzona 9341 incorporated. 5x layers of Belzona 9371 utilising Belzona 1981 resin

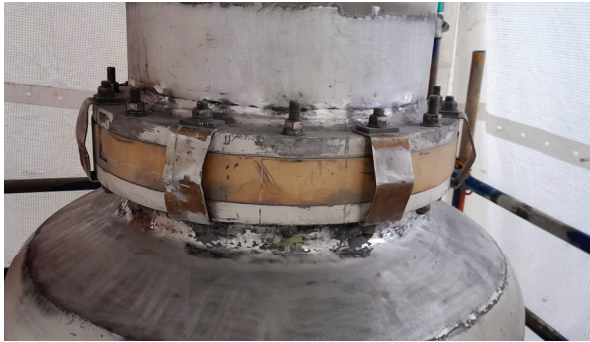
This particular electrical switch gear was leaking 70 kg (154 lbs) of SF₆ per month. This was not only harmful for the planet, but resulted in substantial fines for the Energy Company. The Customer sought a solution to mitigate the leak.

Flange leaking SF₆ gas

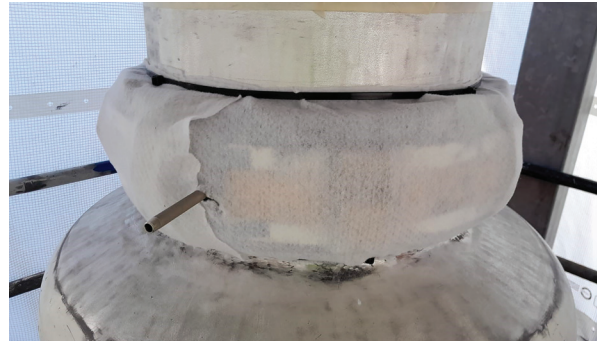
Prepared flange, ready for application
